The Chesapeake Bay Breakwater Database Project Hurricane Isabel Impacts to Four Breakwater Systems

Shoreline Studies Program
Virginia Institute of Marine Science
College of William & Mary

May 2005

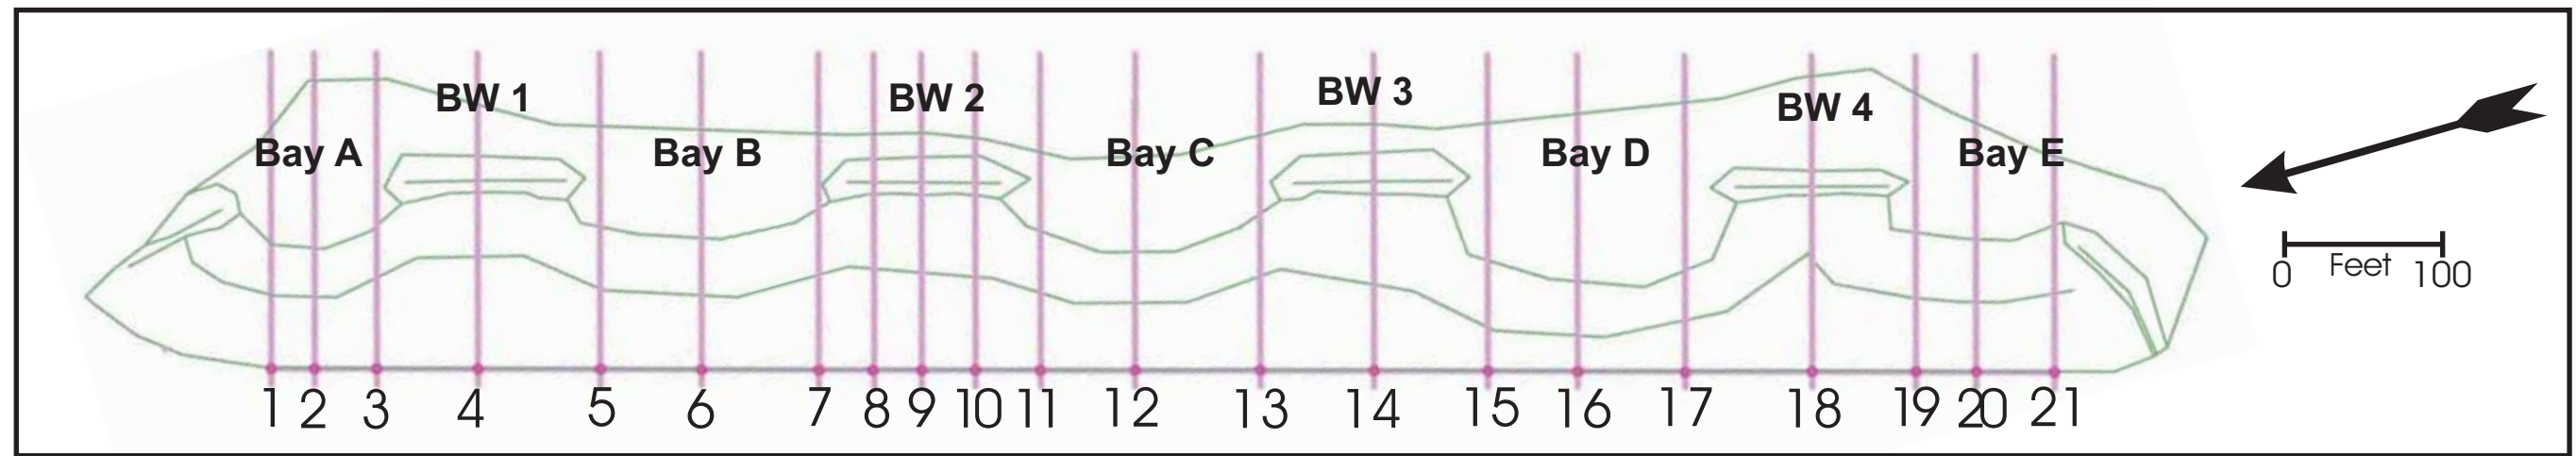
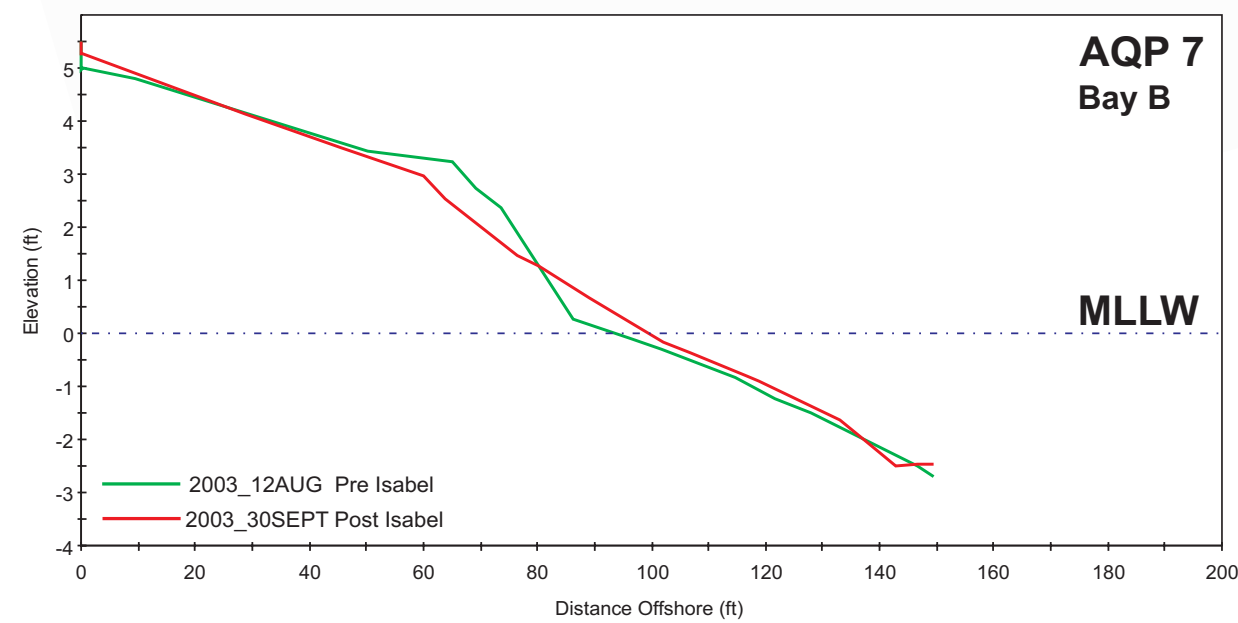
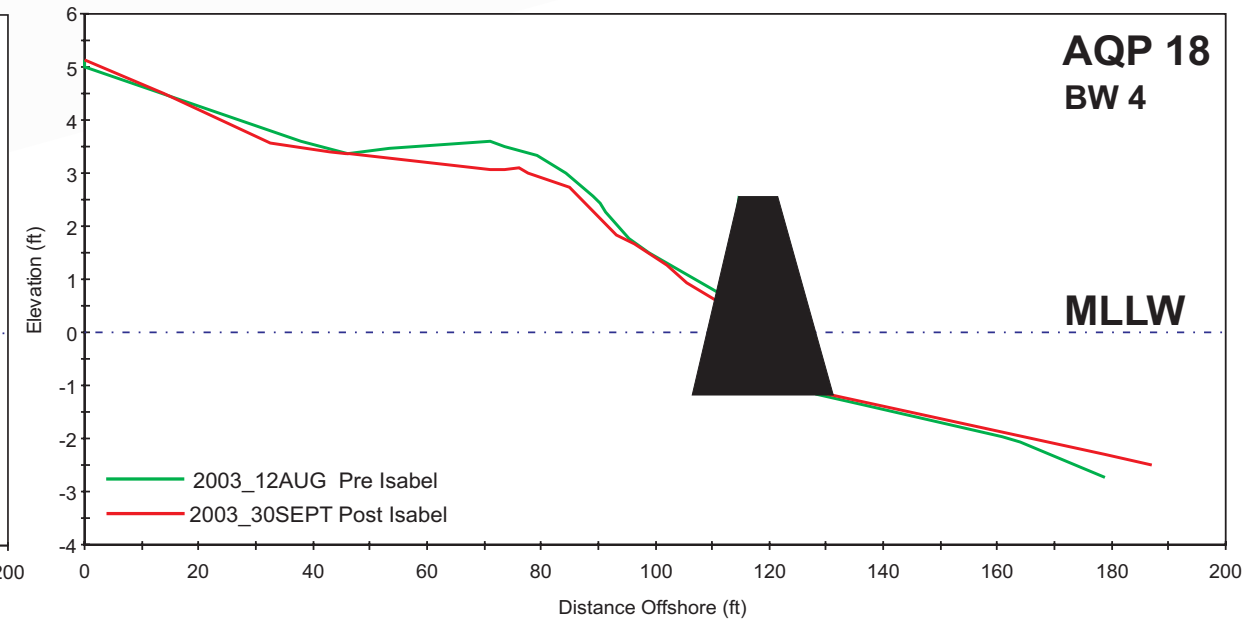
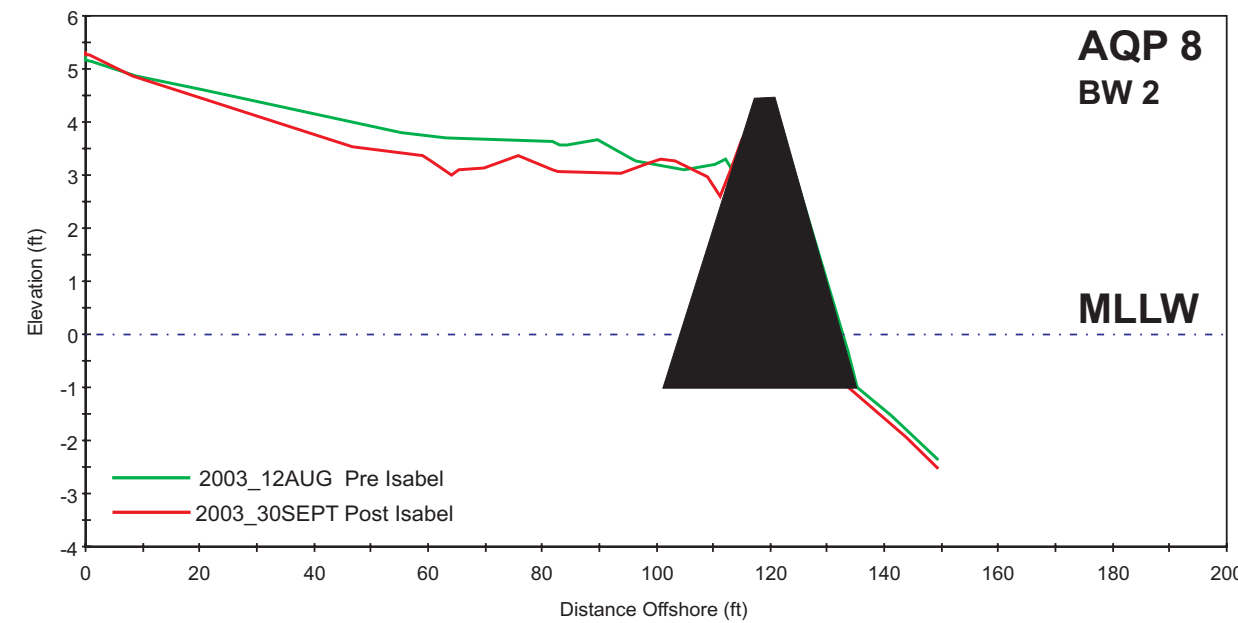
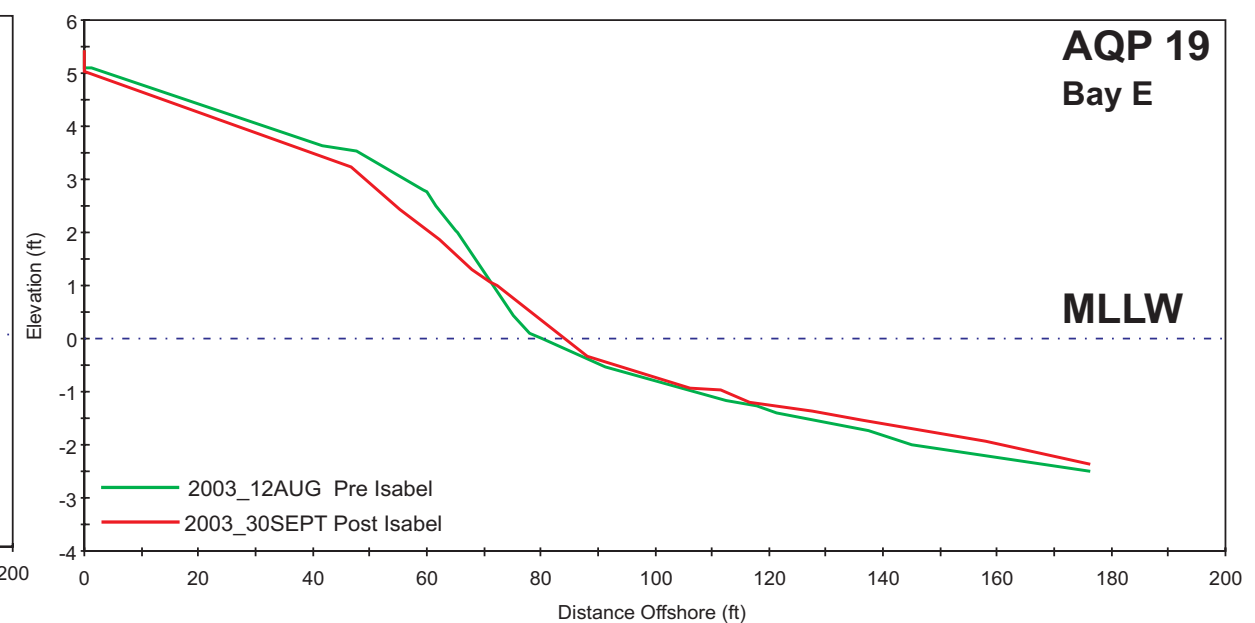
Figure 16. Aquia Landing baseline and selected pre and post storm cross-sections

The survey baseline at Aquia Landing runs along the top of a Jersey wall that separates the public beach from the adjacent access road. The road is about 2 ft lower than the beach at the junction of the wall. Aerial imagery pre- and post-Isabel show that enough sand, about 1 ft, overwashed the wall to completely cover the access road (Figure 15). The shift in shoreline position was mostly landward after Isabel. Typical bay beach profiles (Figure 16) show a cut and fill scenario while the tombolo beach in the lee of each breakwater unit were sheared down about 0.5 feet. Little or no scour existed in front of the breakwaters while slight infilling occurred in each embayment. A slight increase in elevation was measured on the river side of the wall as the sand was moved up and over except where one scour hole occurred at the beach/wall junction. In addition, a reduction in vegetation in the lee of each breakwater occurred (Figure 17). The walkover to the beach was destroyed, and the bathhouse was flooded by the 8.6 ft MLLW surge that covered everything at the site.

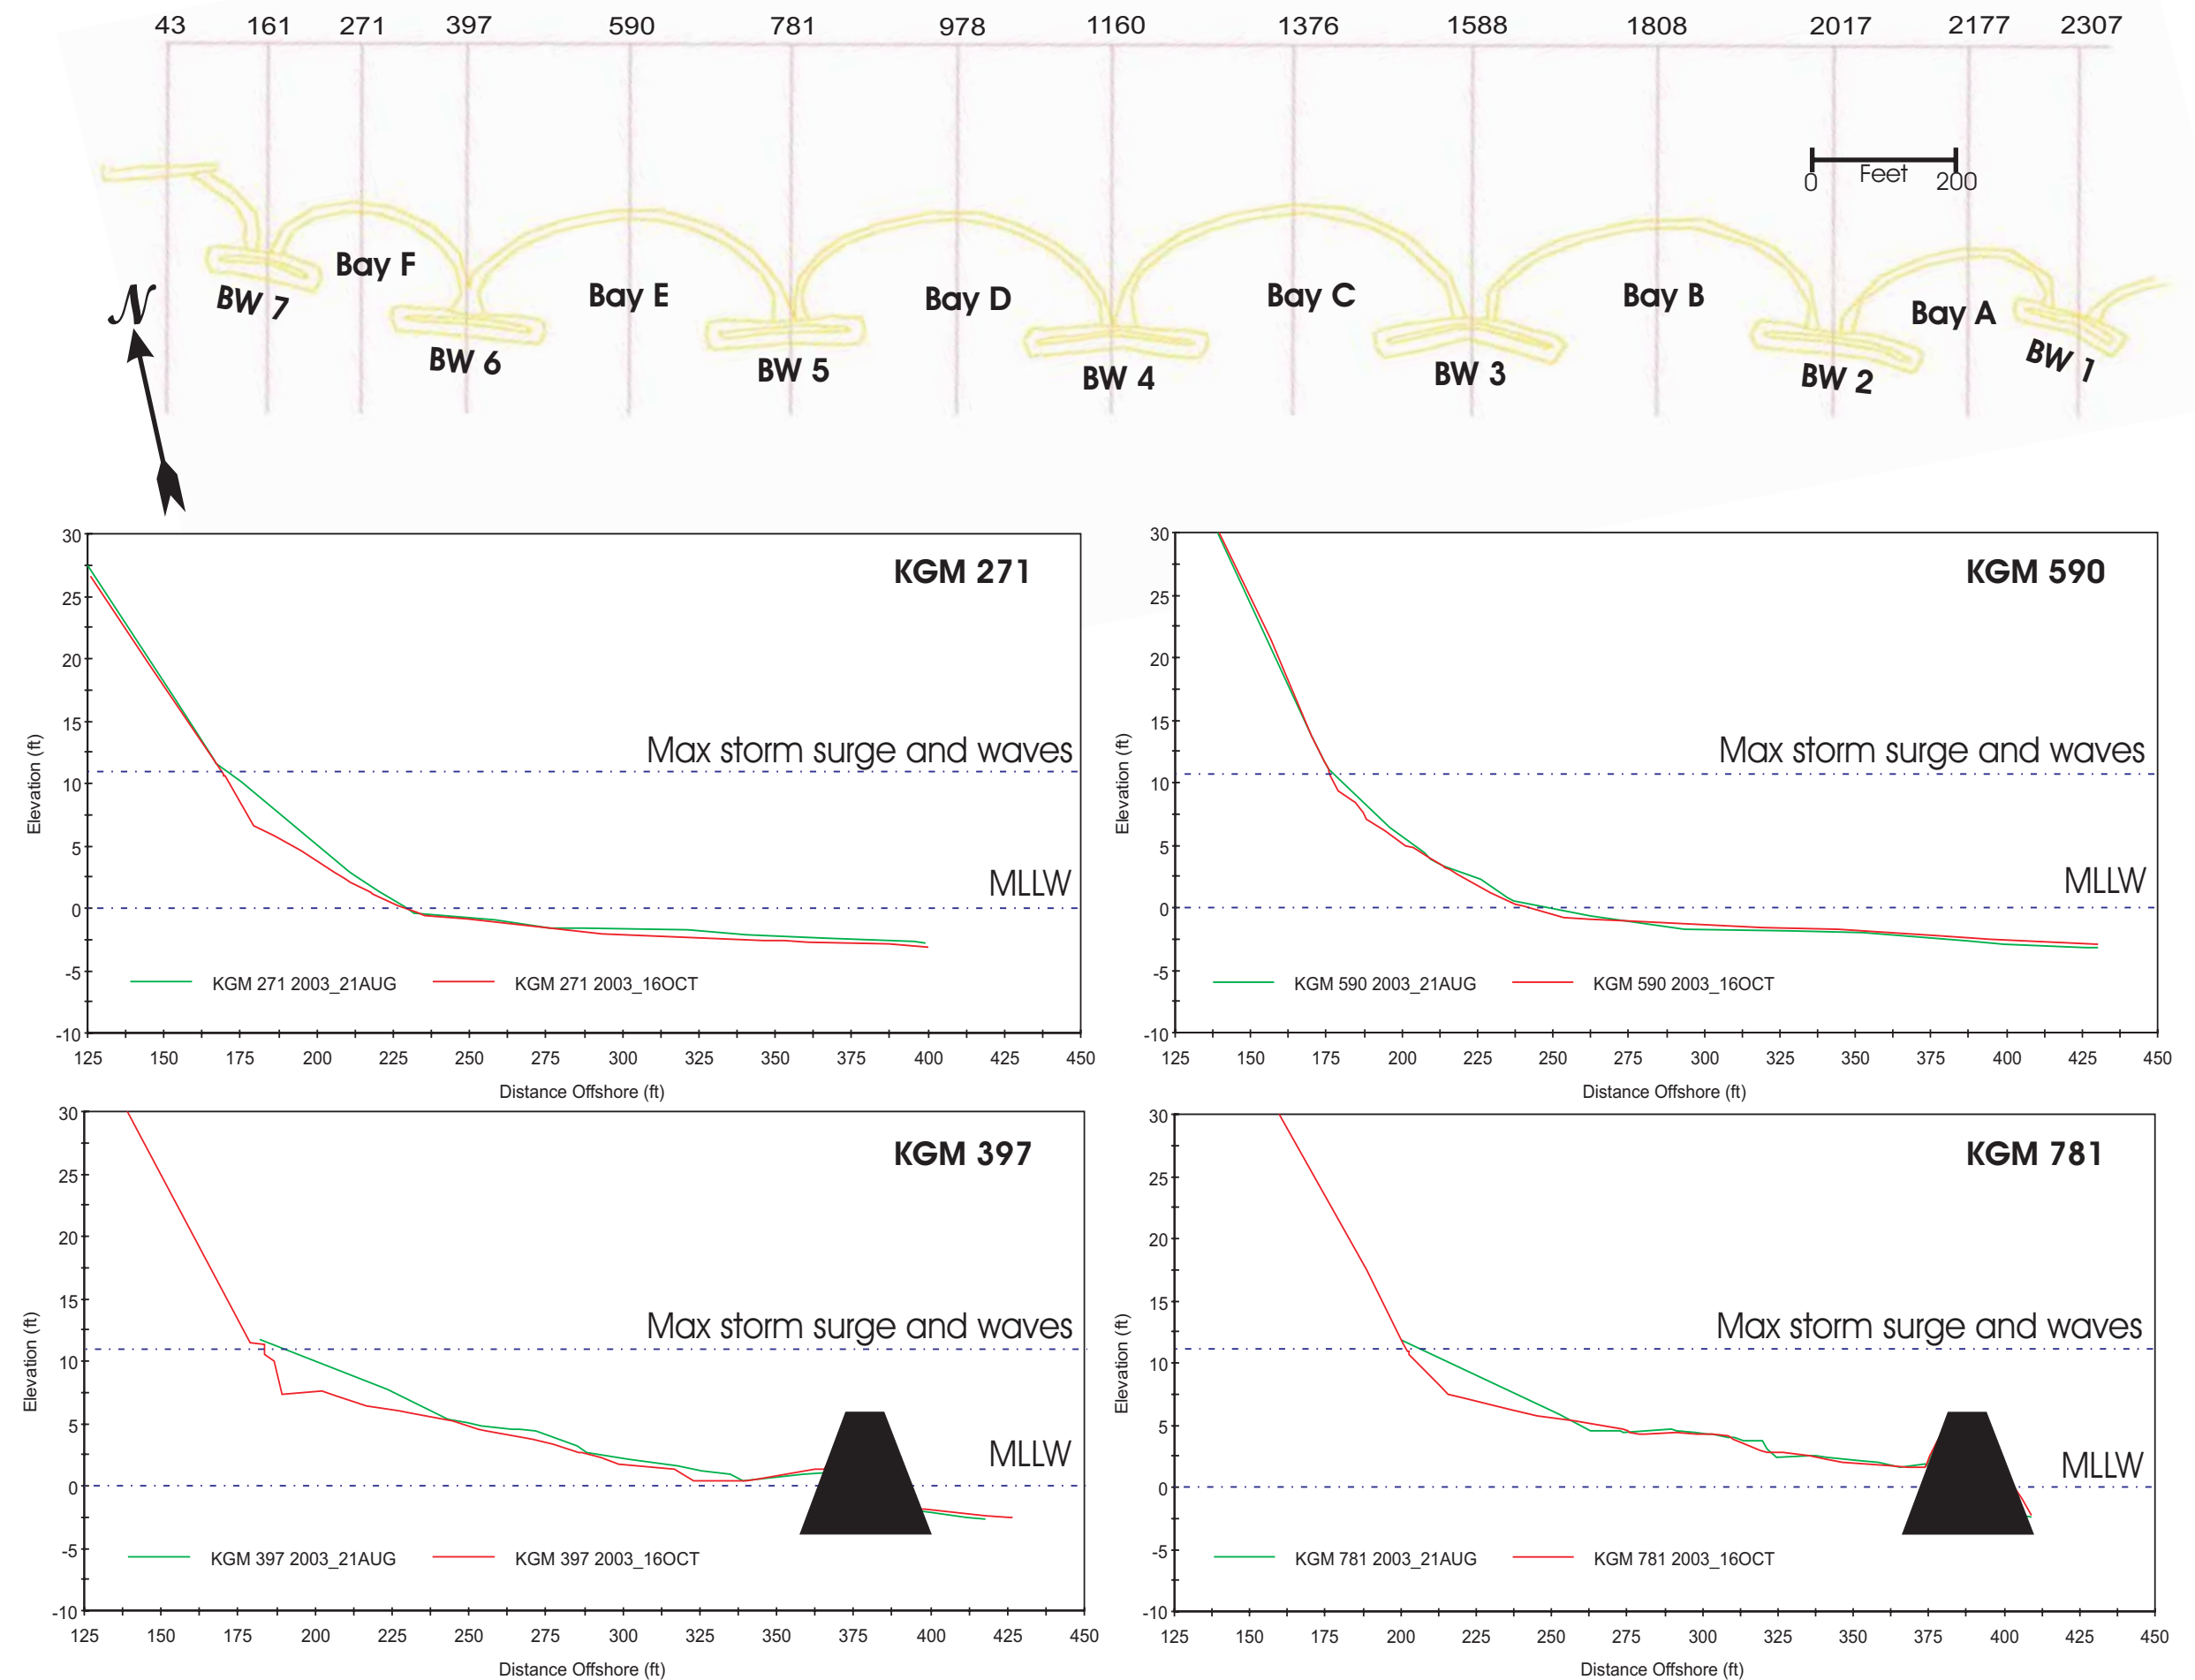
Figure 20. Kingsmill baseline and selected pre and post storm cross-sections.

Pre- and post-Isabel aerial imagery of the site show slight changes in shore position (Figure 19). Each tombolo apex had a tendency to shift upriver. Measurable base of bank recession occurred along much of the project, but it was particularly prevalent adjacent to each embayment. These changes are illustrated in the typical bay and breakwater profiles in Figure 20. The combination of storm surge and wave runup limits were measured in the field and are shown for each typical profile at just over 10 ft MLLW. This was a significant event for the site, yet overall damage was minimized by the heavily vegetated backshore/base of bank (Figure 21). Post-Isabel recovery is shown in Figure 19; the beach planforms have returned to approximately their pre-storm positions.

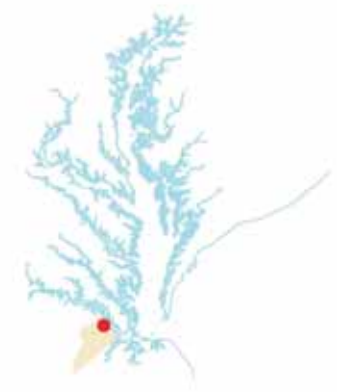
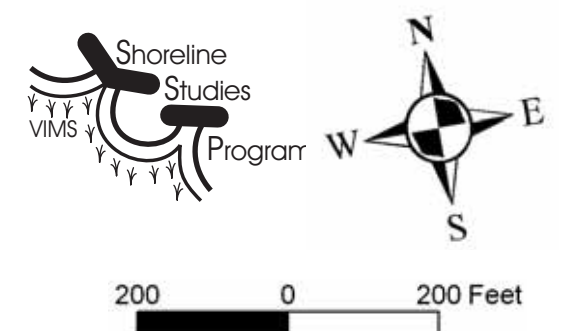
Figure 23. Van Dyke low-level pre- and post-Hurricane Isabel and recovery ortho-rectified aerial photos.

Aerial imagery pre- and post-Isabel shows mostly landward shifts in the positions of both the shoreline and base of bank (Figure 23). Reduction in tombolo size are seen behind BW3, BW4, BW5, BW6 and also BW7 which had the narrowest attachment before the storm. The adjacent base of bank (BOB) along these structures also receded. Significant BOB recession also occurred in Bay A. General BOB stability is seen between BW2 and BW4 as well as between BW7 and BW8. These trends are shown in typical profiles for select bays and breakwaters (Figure 24). The combination of storm surge and wave height exceeded 11 ft MLLW, about 3 feet higher than project design. Post-storm recovery shows the shore planforms have returned to approximately their pre-storm configuration (Figure 23).

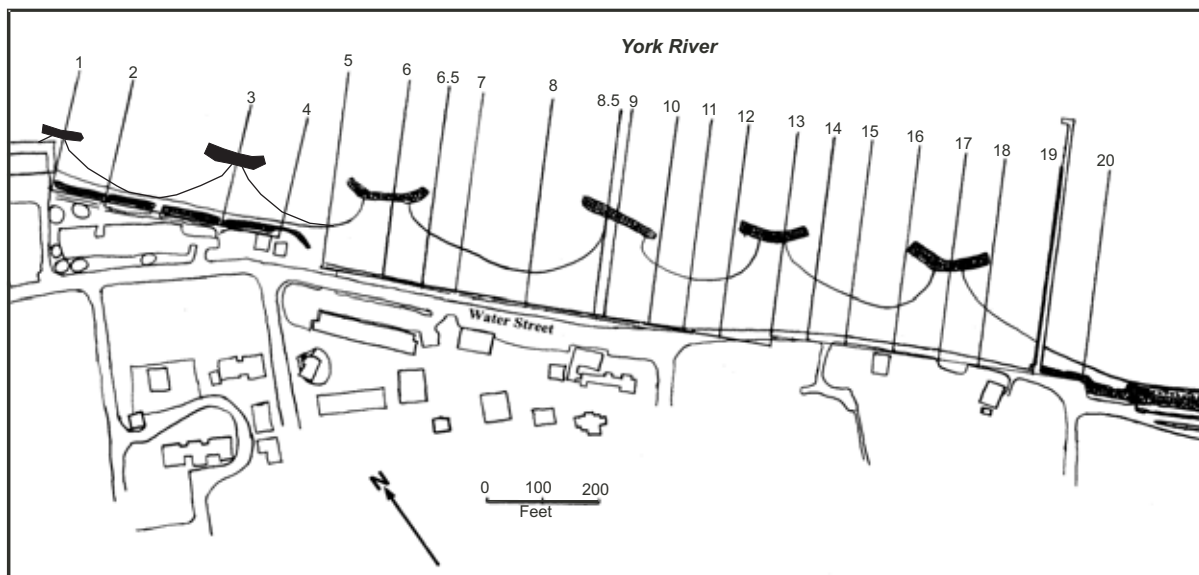
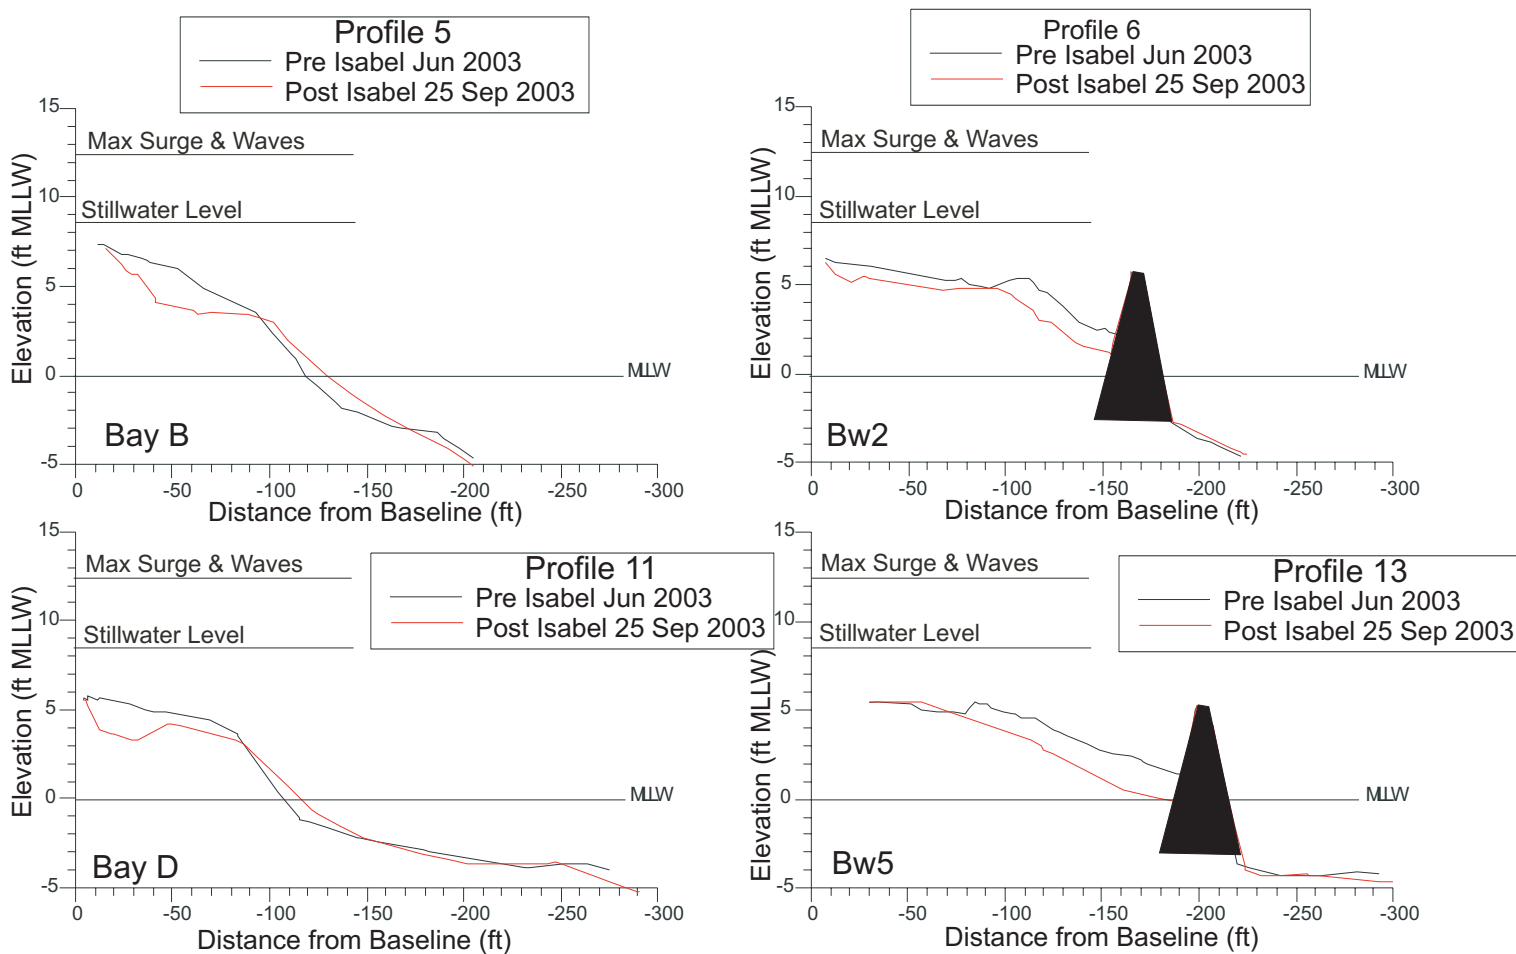
Figure 28. Yorktown baseline and selected pre and post storm cross-sections.

Pre- and post-Isabel low level aerial imagery show a narrowing of each tombolo and a landward shift of sand behind each breakwater unit (Figure 27). The shoreline position in the two middle and largest embayments showed only slight changes after the storm. Typical profiles show cross-sectional changes as a basic cut and fill in the embayments (Figure 28). Shearing occurred across the top of the tombolos as well. Some sand was lost to the offshore after the storm but the County filled the beach to its pre-storm profile shortly after the hurricane. Post-storm recovery about one year later shows shore planforms to have returned to their pre-storm position. A noticeable shore advance is seen in Bay C.

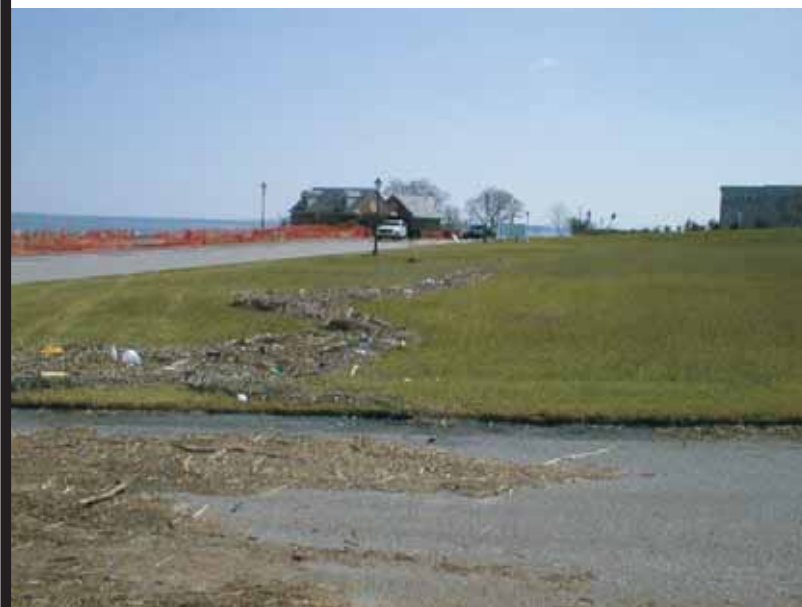
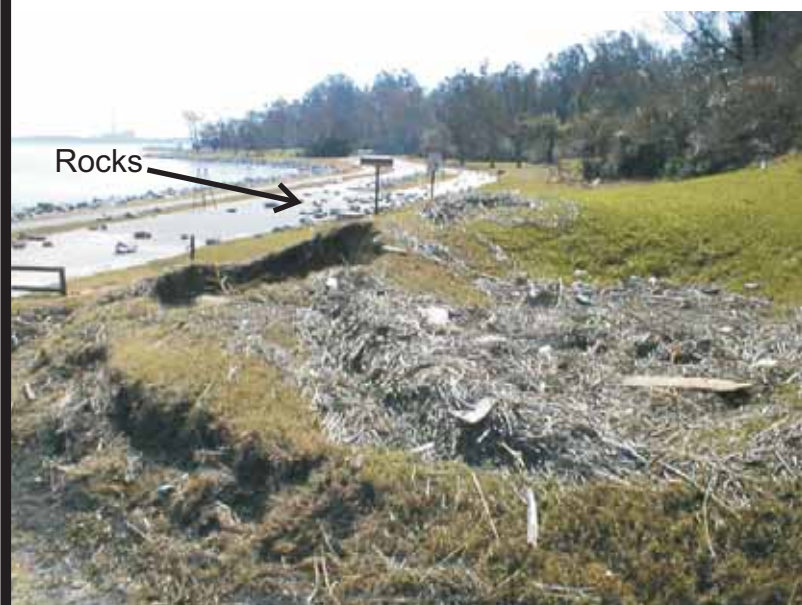
Figure 30. Yorktown A) backshore and B) post storm wrack line and C) adjacent shore impacts.

Sand was carried into the adjacent street but recent granite block "backstops" helped reduce this tendency. These blocks measuring about 1 ft square, 5 feet long, and weighing about 1 ton were easily shifted around by the storm waves. Several areas of scour occurred along the backshore/sidewalk/road juncture (Figure 29), but post storm clean up and added fill restored the public beach to use by late October 2003. The businesses along the waterfront were severely impacted, and it took several months for their rehabilitation due to water damage, but they are presently operating. Figure 30 shows a low backshore along Water Street in Yorktown as well as the storm wrack lines. At Colonial National Historical Park, just downriver from Yorktown, small rocks from the revetment along the shoreline were scattered on the road, and the adjacent upland bank was severely scarped.

B
Post-storm
wrack line

C
Post-storm
wrack line
downriver

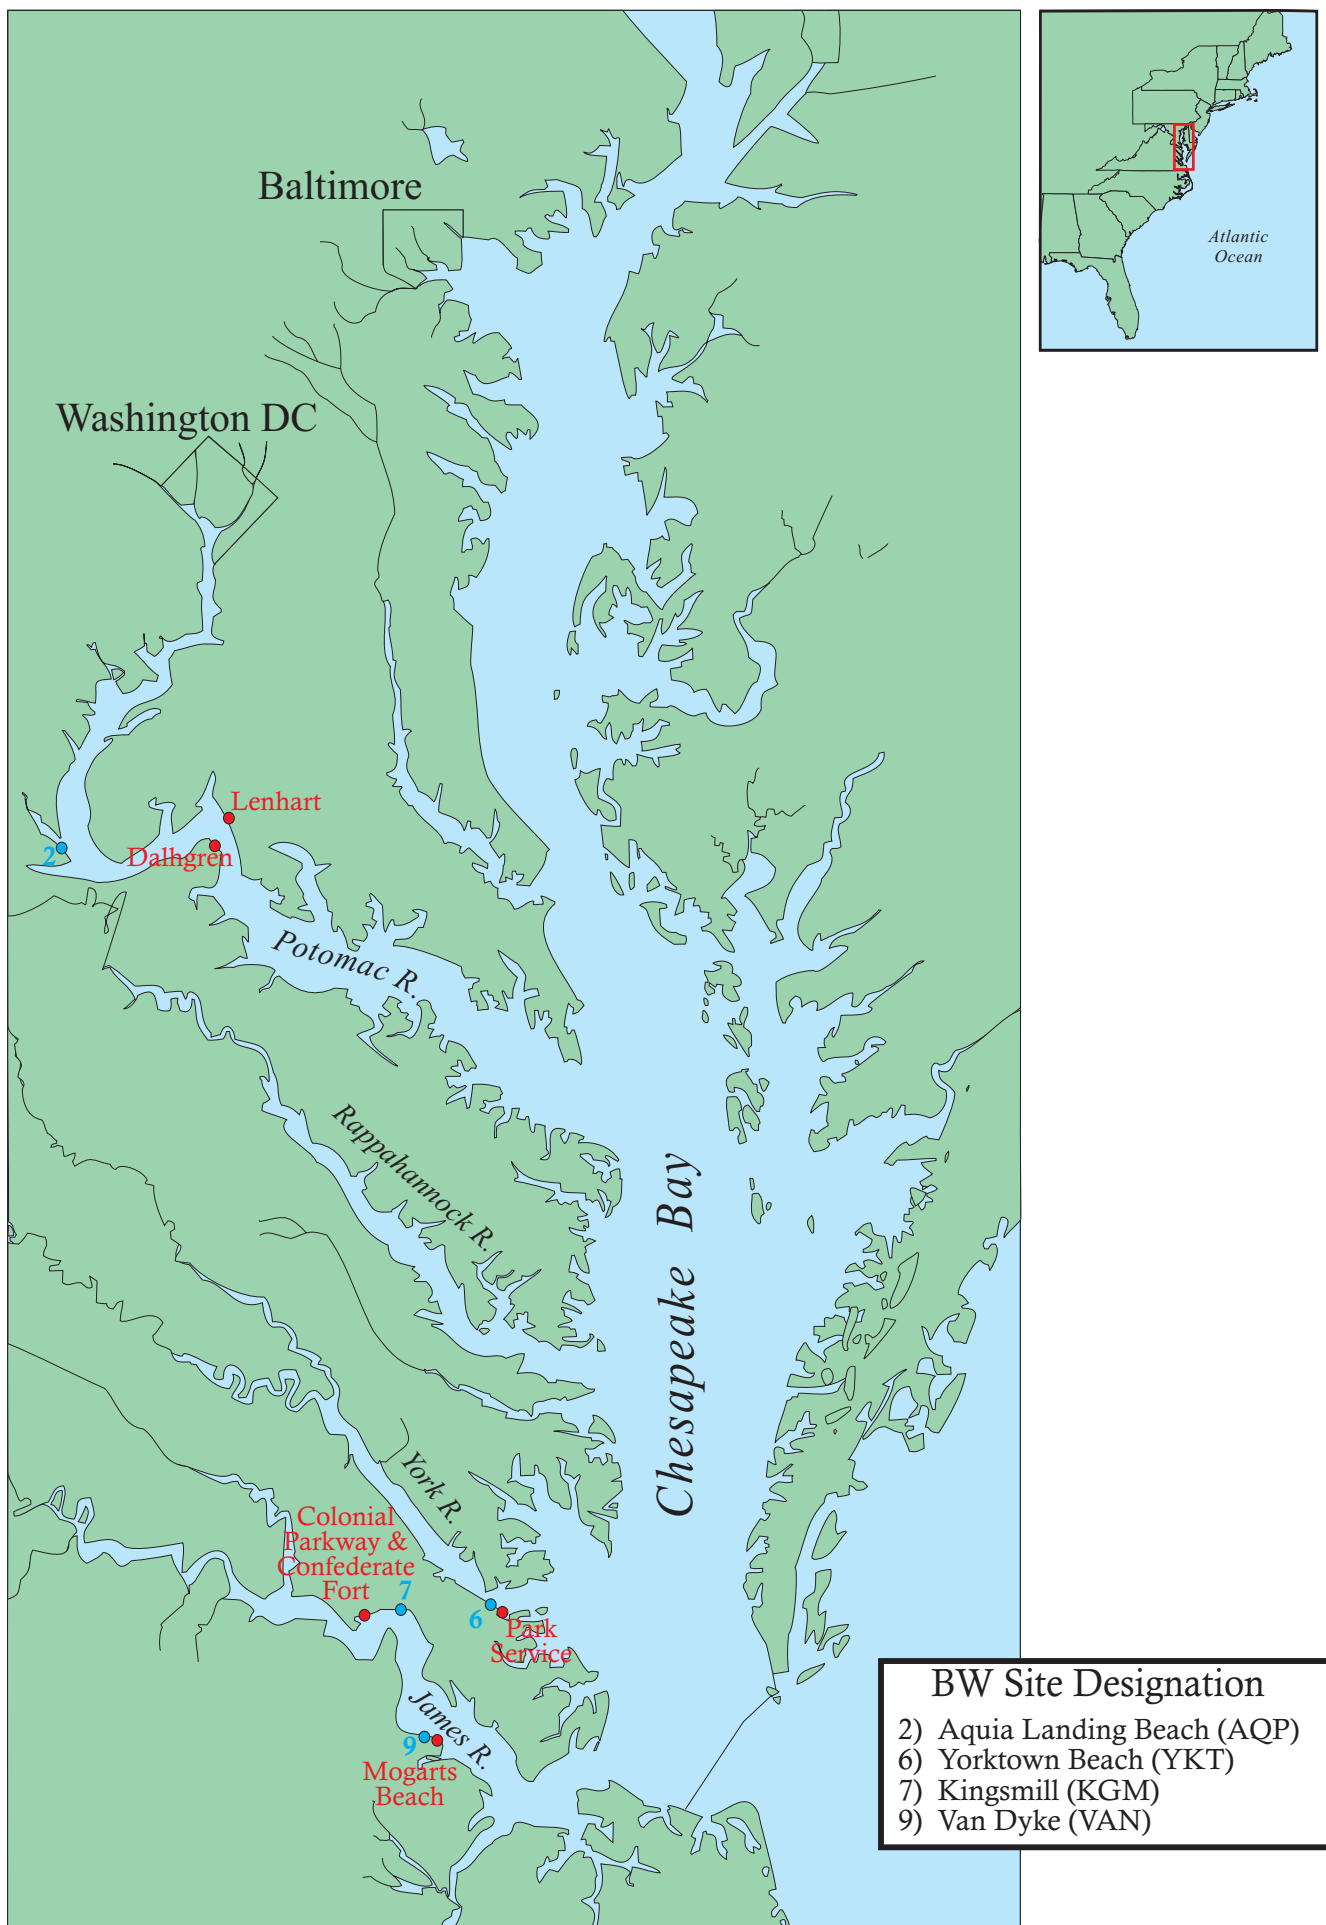
Figure 31. Location of breakwater sites used in this report (blue) and other impacted sites (red).

Just downriver at two other sites which had no shore protection system, significant change occurred ([Figure 31](#)). Dahlgren is on the south side of the Potomac River just downriver from the Route 301 Potomac River Bridge. Its bank was eroded 15-20 ft threatening upland infrastructure ([Figure 32](#)). On the north side of the Potomac River, Lenhart is slated for development. During the storm, its bank retreated 10-15 ft due to the storm ([Figure 33](#)).
